GOWANDA CAPITAL IMPROVEMENT PROJECT

GOWANDA CENTRAL SCHOOL DISTRICT

PRESENTED BY
ROBERT B. ANDERSON, ED.D.
SUPERINTENDENT OF SCHOOLS
BOARD OF EDUCATION WORKSHOP
SEPTEMBER 12, 2018

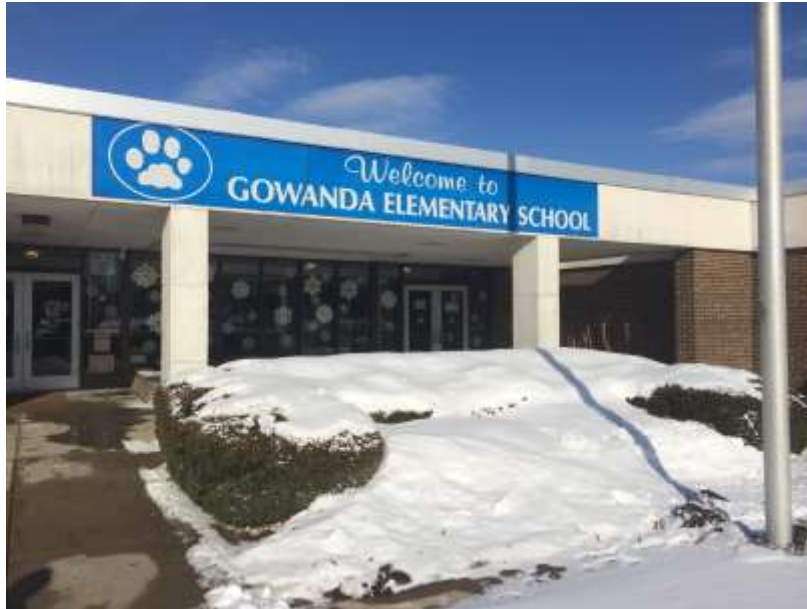
CURRENT ELEMENTARY SCHOOL ENTRANCE

Enhancing security at the entrances/exits is crucial to ensure safety.

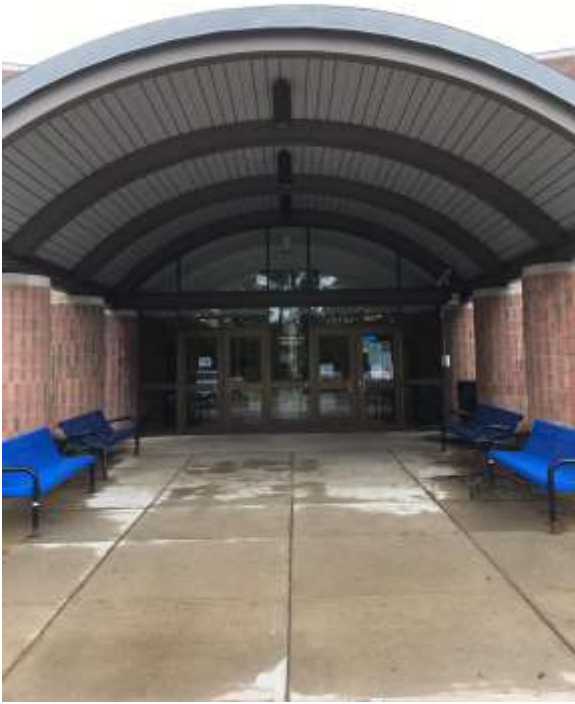
CURRENT MIDDLE SCHOOL ENTRANCE

Although newest entrance, once inside the door, visitors to Gowanda Middle School gain complete access to the building.

A remodeled vestibule with enhanced security will allow administrative staff to vet visitors before granting any access.

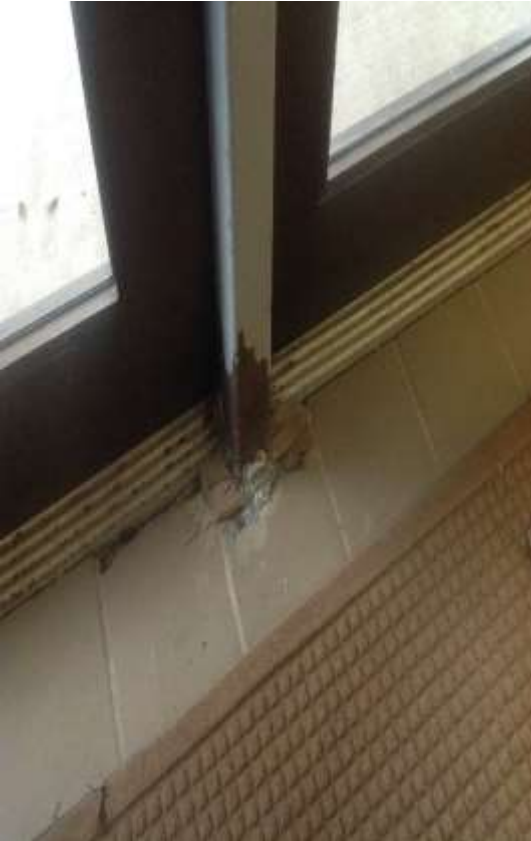
CURRENT MIDDLE SCHOOL ENTRANCE

- Repairs needed as well

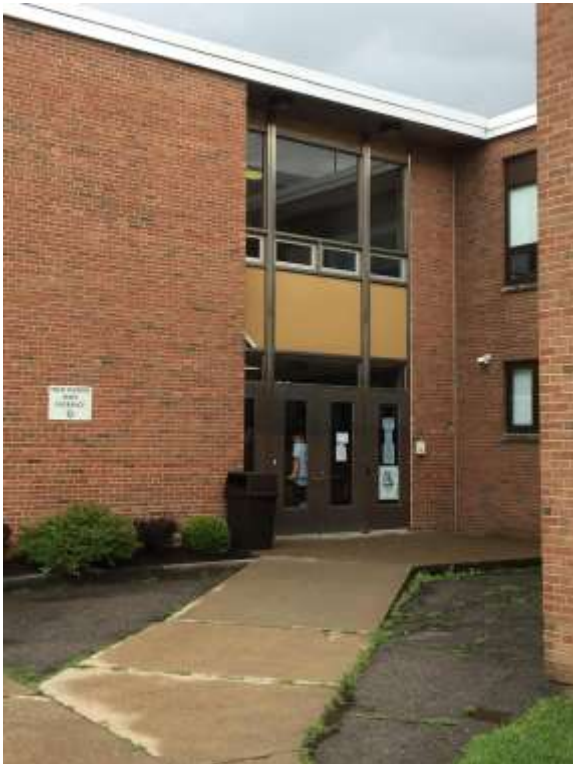
CURRENT HIGH SCHOOL ENTRANCE

The nondescript High School entrance lacks distinction that it is actually an entrance. Once inside the door, visitors also have complete access to the high school. Adding a secure vestibule will enhance security and energy efficiency and help with way-finding.

The original stainless steel doors expand and contract and do not close properly, causing the corridor to heat quickly in summer and cool quickly in winter.

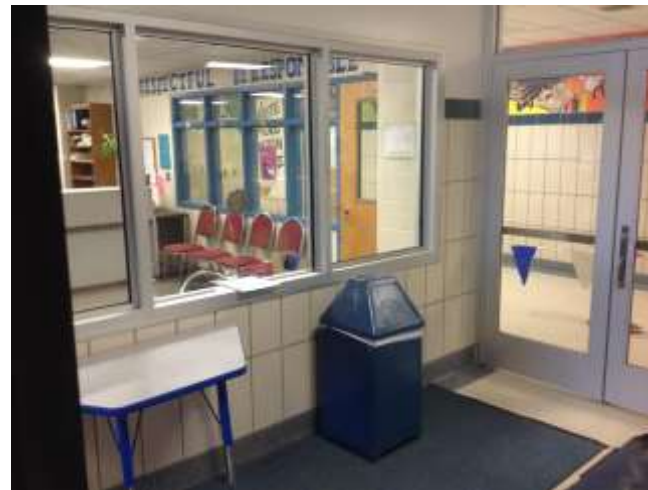
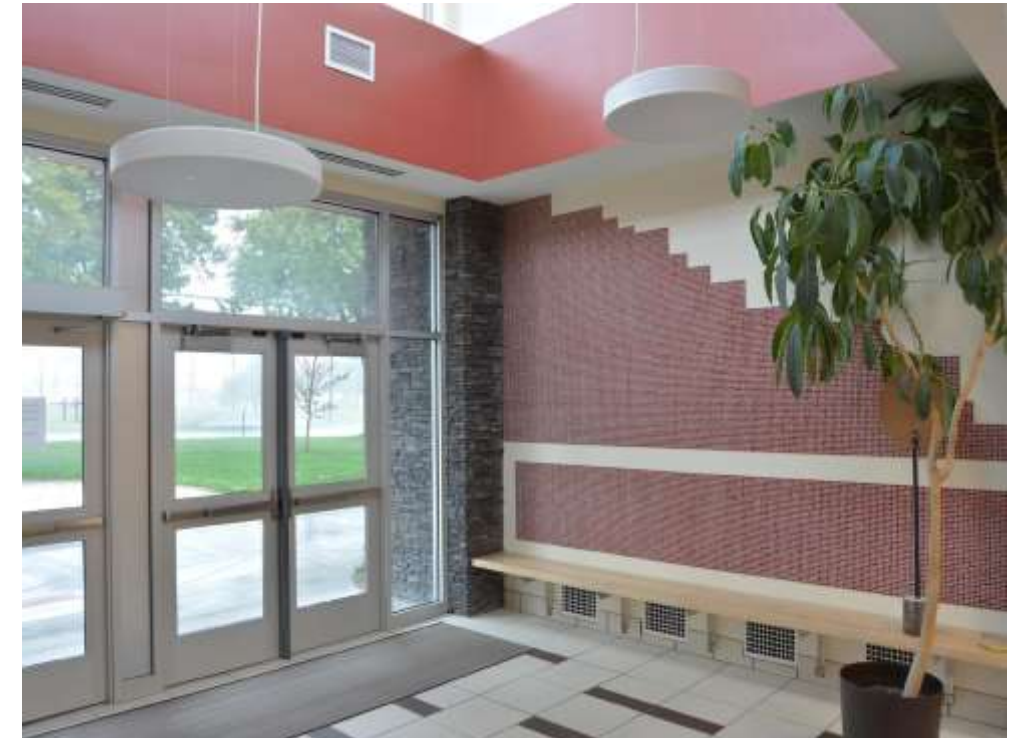
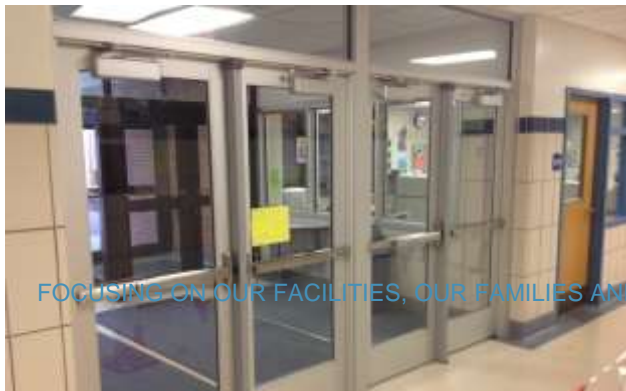
BUILDING SCOPE SECURE ENTRANCES AT ELEMENTARY, MIDDLE & HIGH SCHOOLS

Benefits of upgrading the entrances include total visual control of the parking areas and sidewalks near the schools prior to unlocking doors and granting access. Secure button access controlled at the reception area.

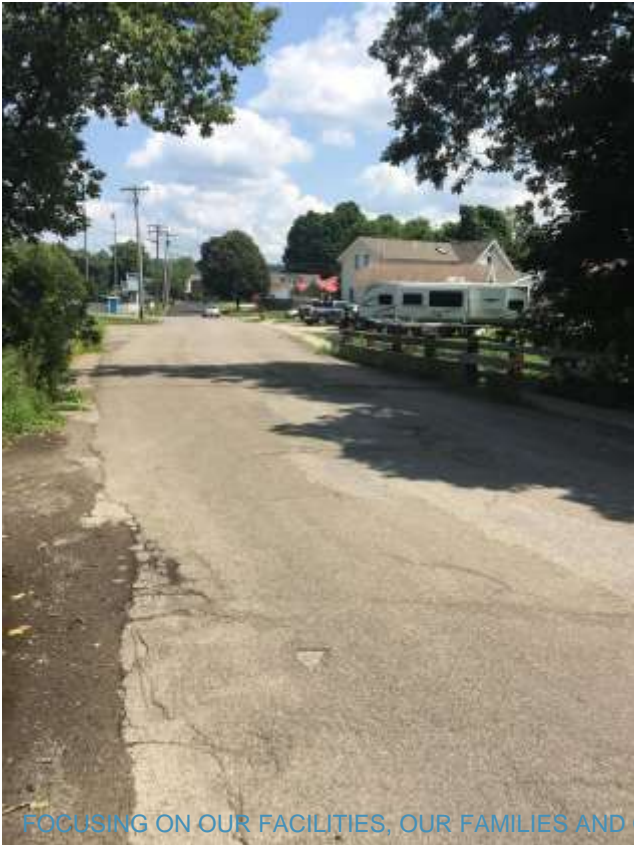
PANTHER STREET BRIDGE WAS 'YELLOW-FLAGGED' BY NYDOT IN 2013

Panther Bridge – a narrow bridge with one walkway – is the main access point to the Gowanda district. It is HEAVILY used by students, staff and the community for pedestrian, car and bus traffic.

Panther Bridge was “yellow-flagged” by the New York State Department of Transportation in 2013. According to a document titled “INSPECTION FLAGGING PROCEDURE FOR BRIDGES” on the DOT website, it is “a structural flag ... is used to report a potentially hazardous structural condition which, if left unattended, could become a **clear and present danger.**”

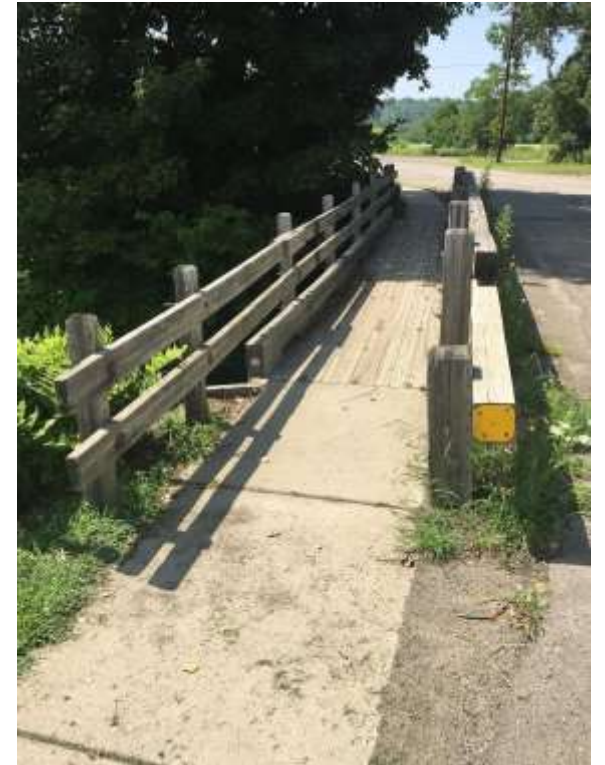
PANTHER STREET BRIDGE

You can plainly see in these images the significant crumbling rust, rotting wood and overall deterioration of Panther Bridge.

It has been well-documented over the past decade that aging spans and bridges across our country are failing. Panther Bridge is overdue for rehabilitation.

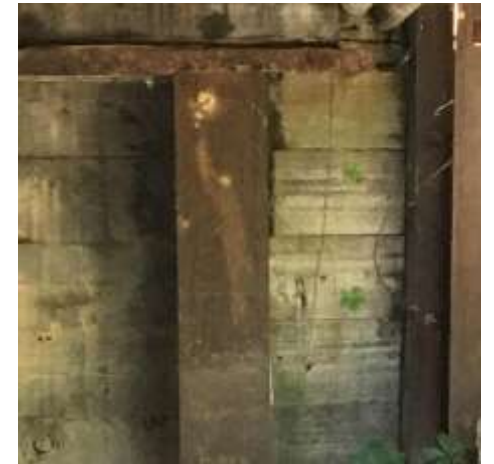
NYS DOT reported on October 13, 2013:

- End Stem Piles had face flange loss;
- End Pile No. 5 had 43% face flange & 18% end flange loss.
- Bridge YELLOW Structural Flag

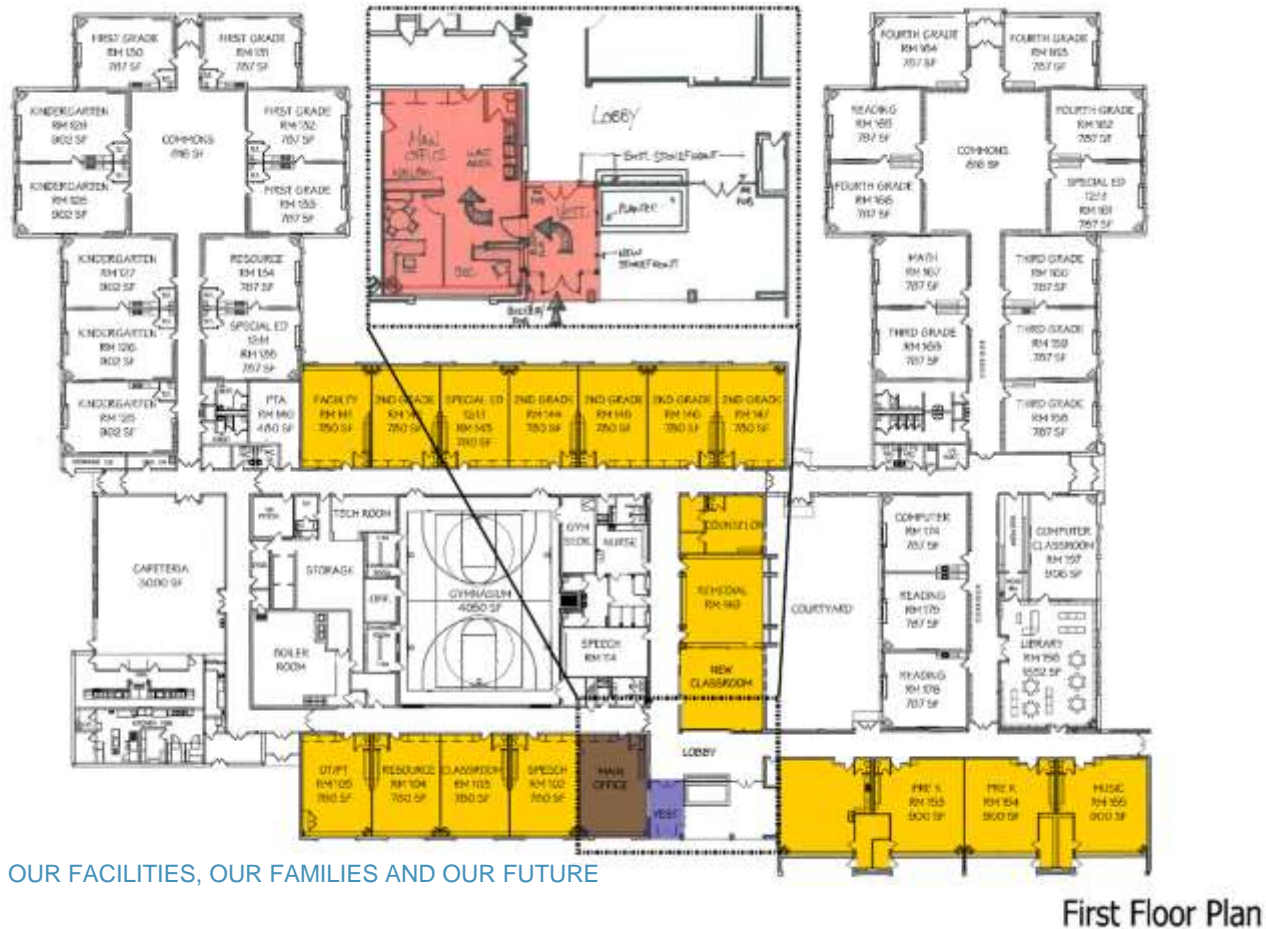
First Floor Plan

- SECURE ENTRY DESIGN
- ENTRY WILL REQUIRE CLASSROOM MOVEMENT
- Classrooms moved/renovated - original 1966

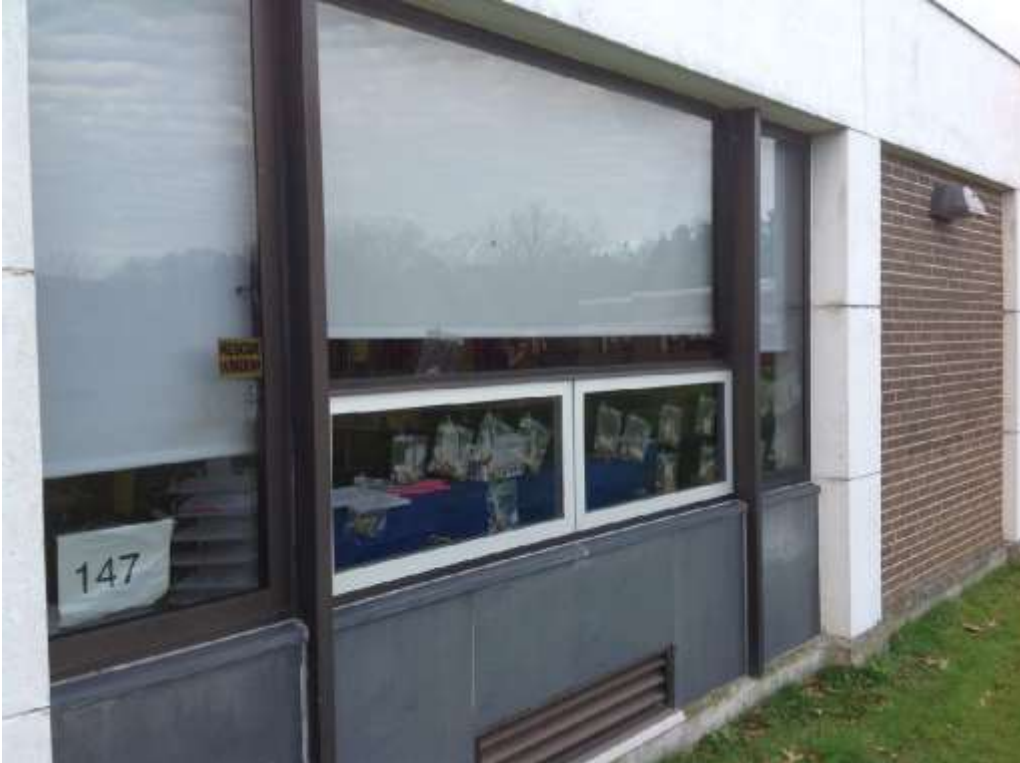
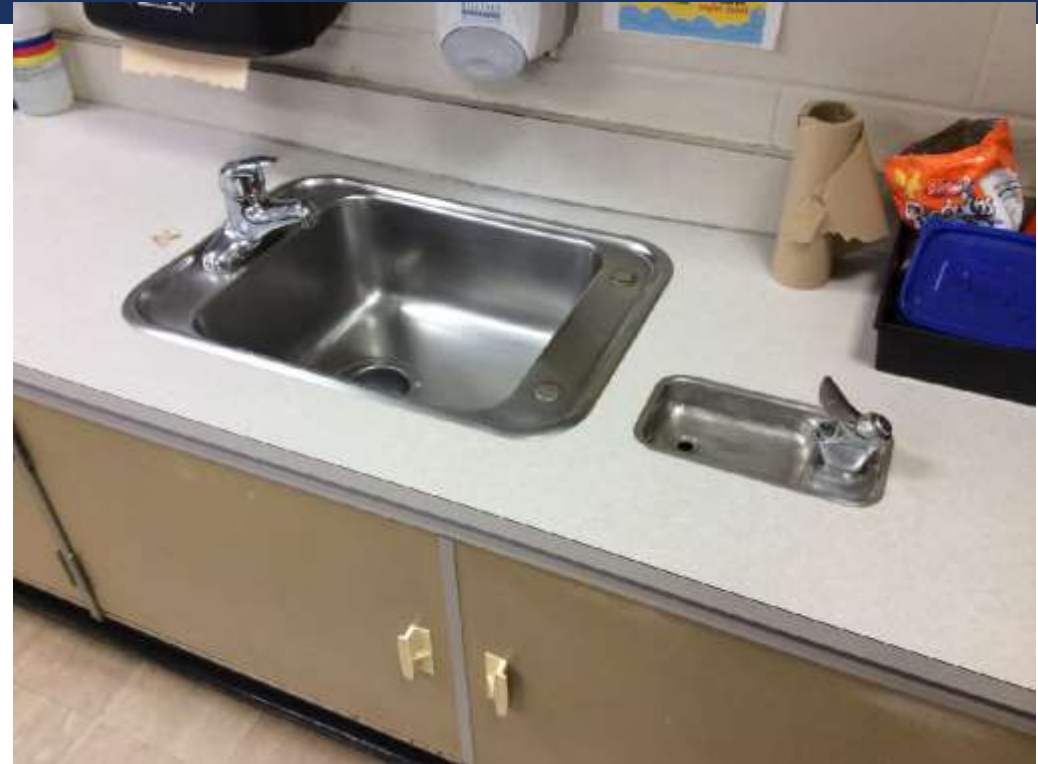
WINDOWS AND VENTILATION

Windows single pane; ventilation units poor working condition- original 1966

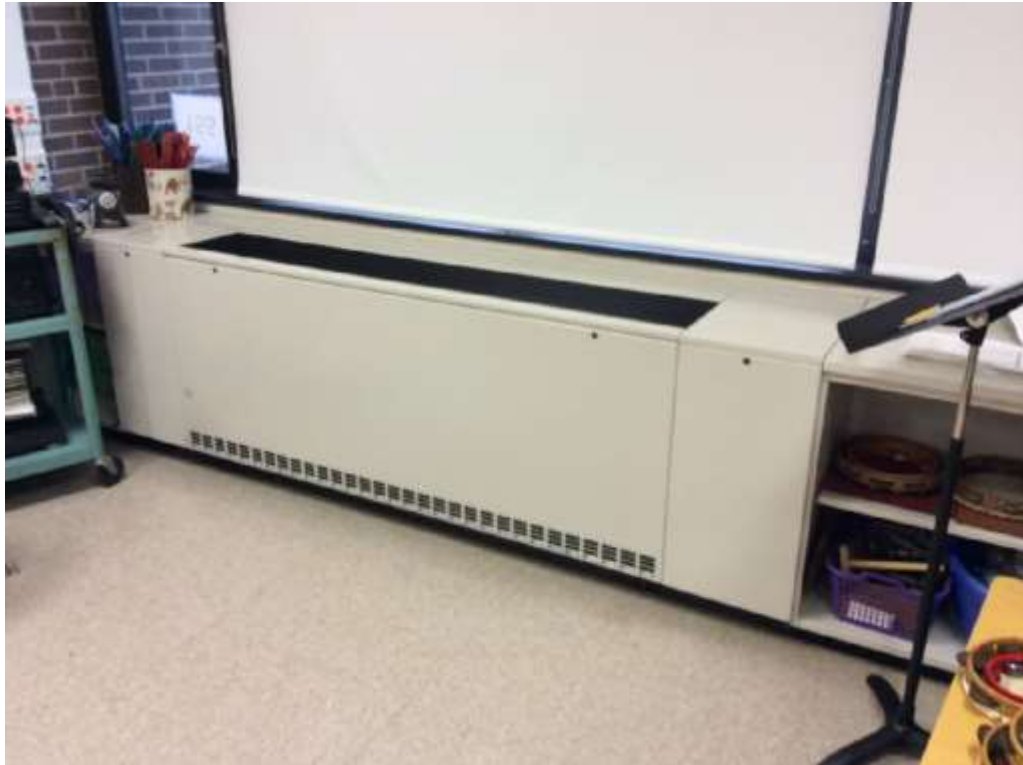
- hot water unit ventilators are in poor working order and have reached the end of their useful life expectancy.

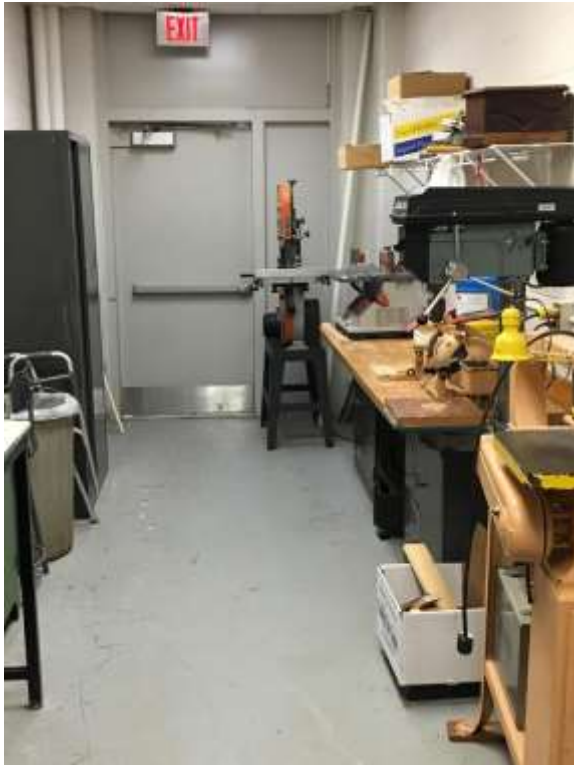
CLASSROOM RENOVATION: HS TECHNOLOGY: STORAGE AND SAFETY

- Shop equipment dated and not accessible to students.
- Additional, much needed technology storage space would provide a designated area for overflow and seasonal equipment.

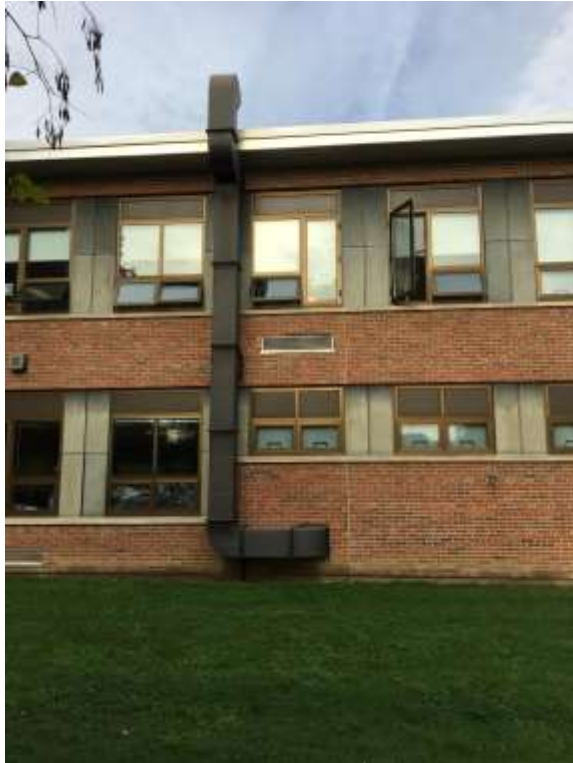
HS TECHNOLOGY

- Current ventilation for plasma cutter & 3D printers viewable in front building plus noise and fumes.

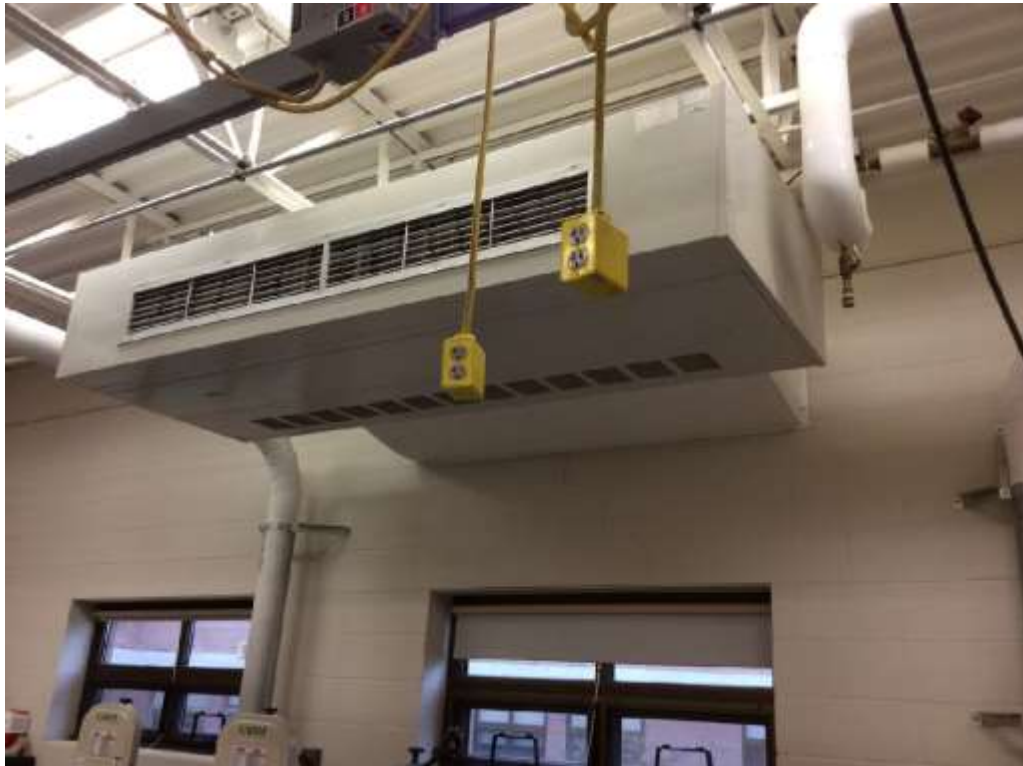
MS TECH RENOVATION

- ❑ Hot water unit ventilators in tech shop providing inadequate ventilation to space.
- ❑ Units hang from building.

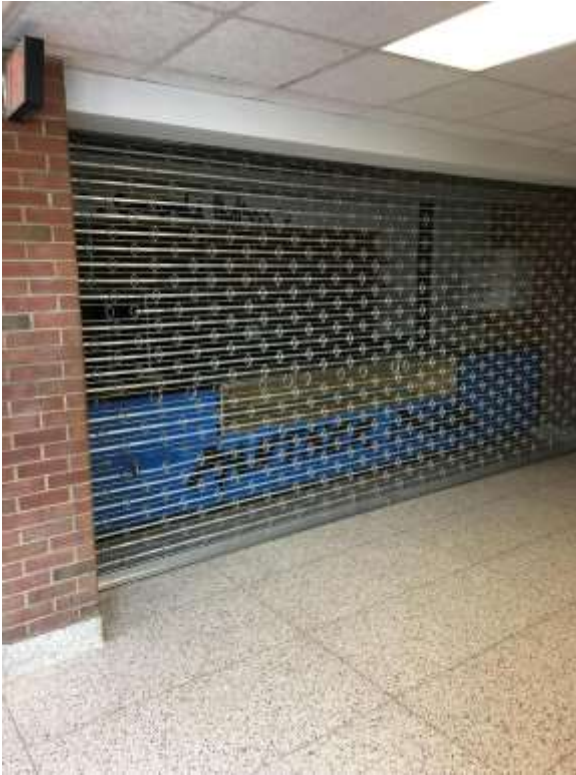
RELOCATING THE SCHOOL STORE AT THE HIGH SCHOOL

The School Store, a mainstay on our campus for decades, is currently located near the High School Library. It would be relocated to accommodate a secure and expanded entrance for students in grades 9 through 12.
Relocated near gym for concessions, access 5-12 grade and visitors.

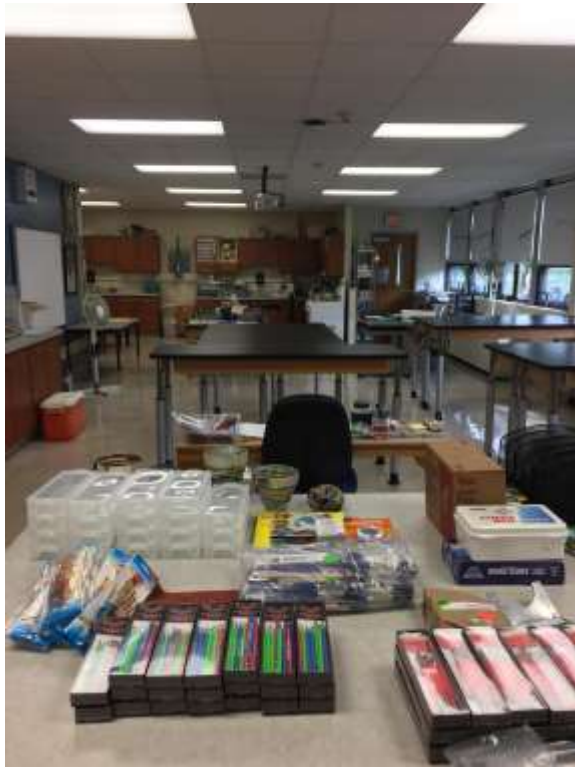
HS ART ROOMS

Storage, cramped space in a repurposed room

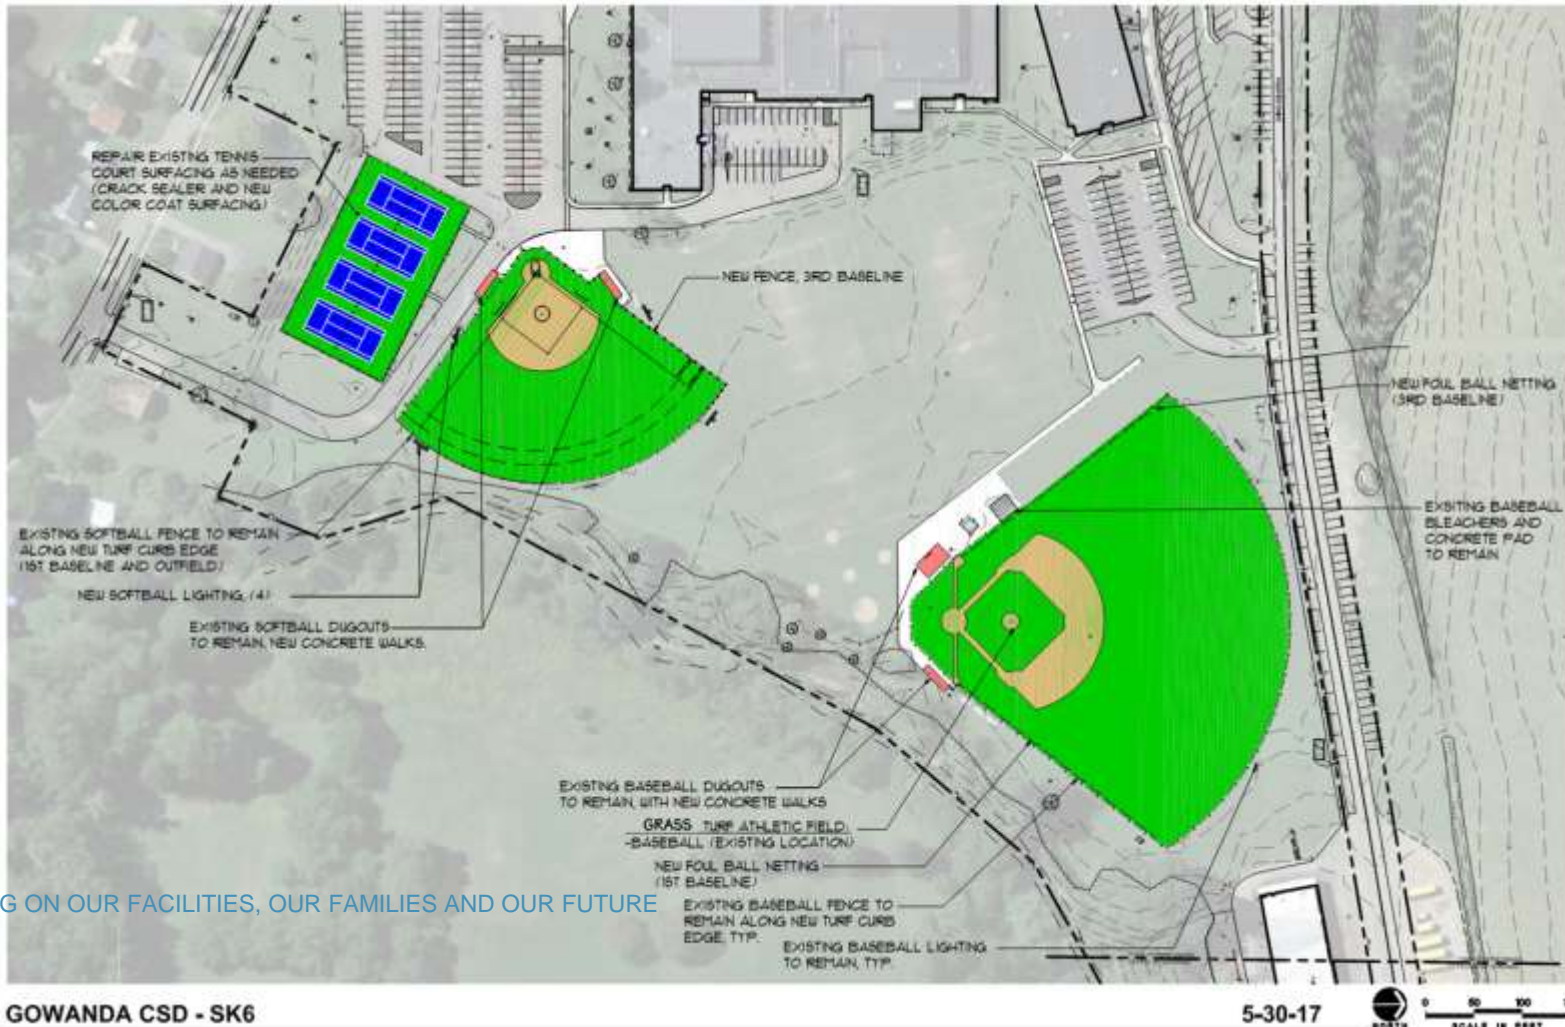
SITE IMPROVEMENT: MIDDLE & HIGH SCHOOLS

- FIELD LIGHTING
- UNDERGROUND DRAINAGE
- 3RD BASE FENCE
- CONCRETE WALKS

- UNDERGROUND DRAINAGE
- GRASS OUTFIELD
- FOUL BALL NETTING
- CONCRETE WALKS

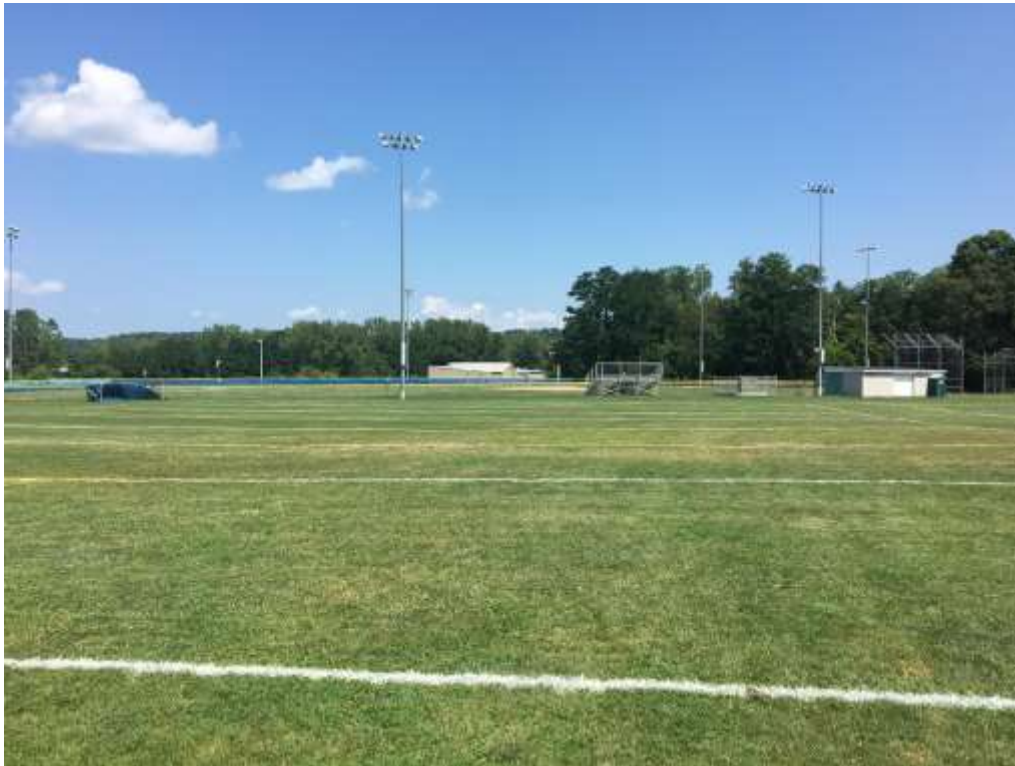
SITE IMPROVEMENT: HS BASEBALL FIELD

- Our athletic fields have limited to no access for the disabled and elderly. This prevents a sizable portion of our community from attending and supporting our student athletes.
- Lack of equity: The boys' baseball field has lights, while the girls' softball field does not.
- Lighting not LED

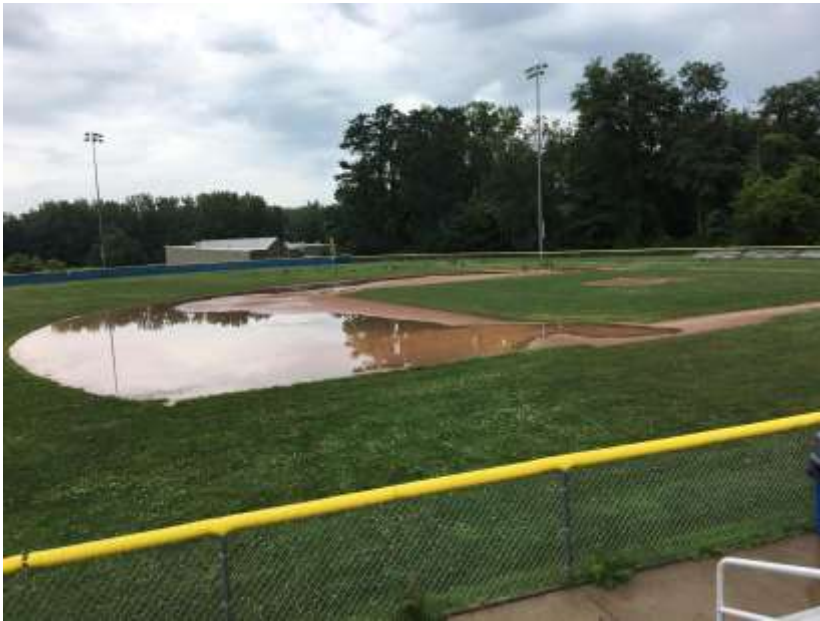
Baseball Field

Both the high school baseball and softball fields suffer from poor drainage.

Late season start; contest impact

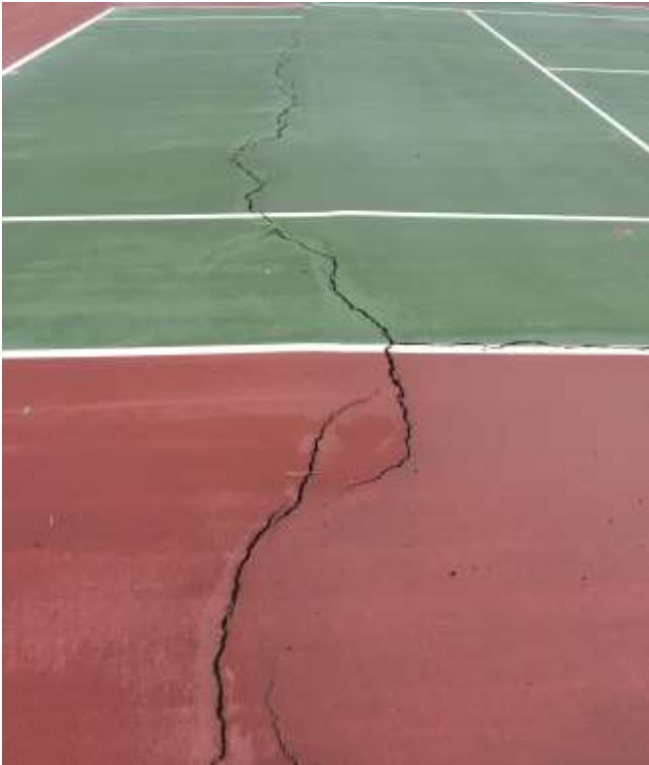
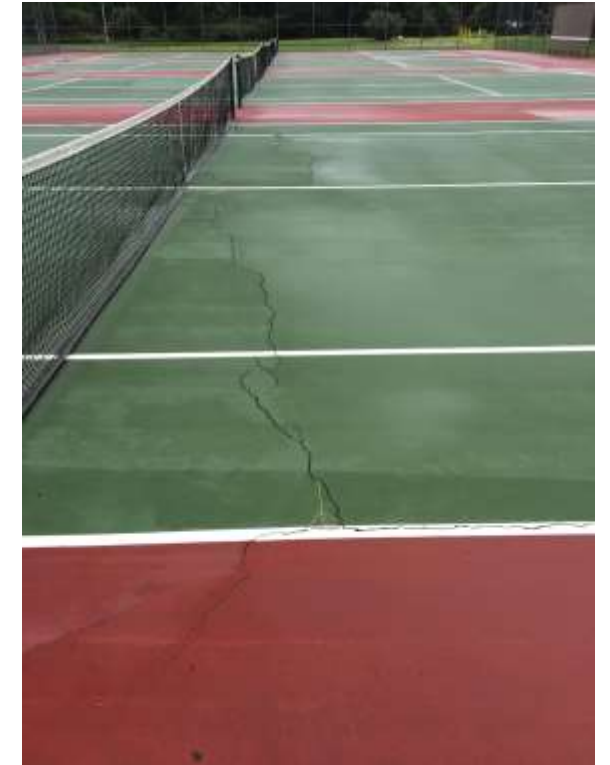
SITE IMPROVEMENT: HS/MS: Tennis Courts

Our tennis courts show signs of significant wear and tear. Some of the cracks – they are virtually fault lines – are so wide and long that they may soon render the courts unusable as they pose potential safety hazards to our students. Small problems get bigger. eg, driveway cracks

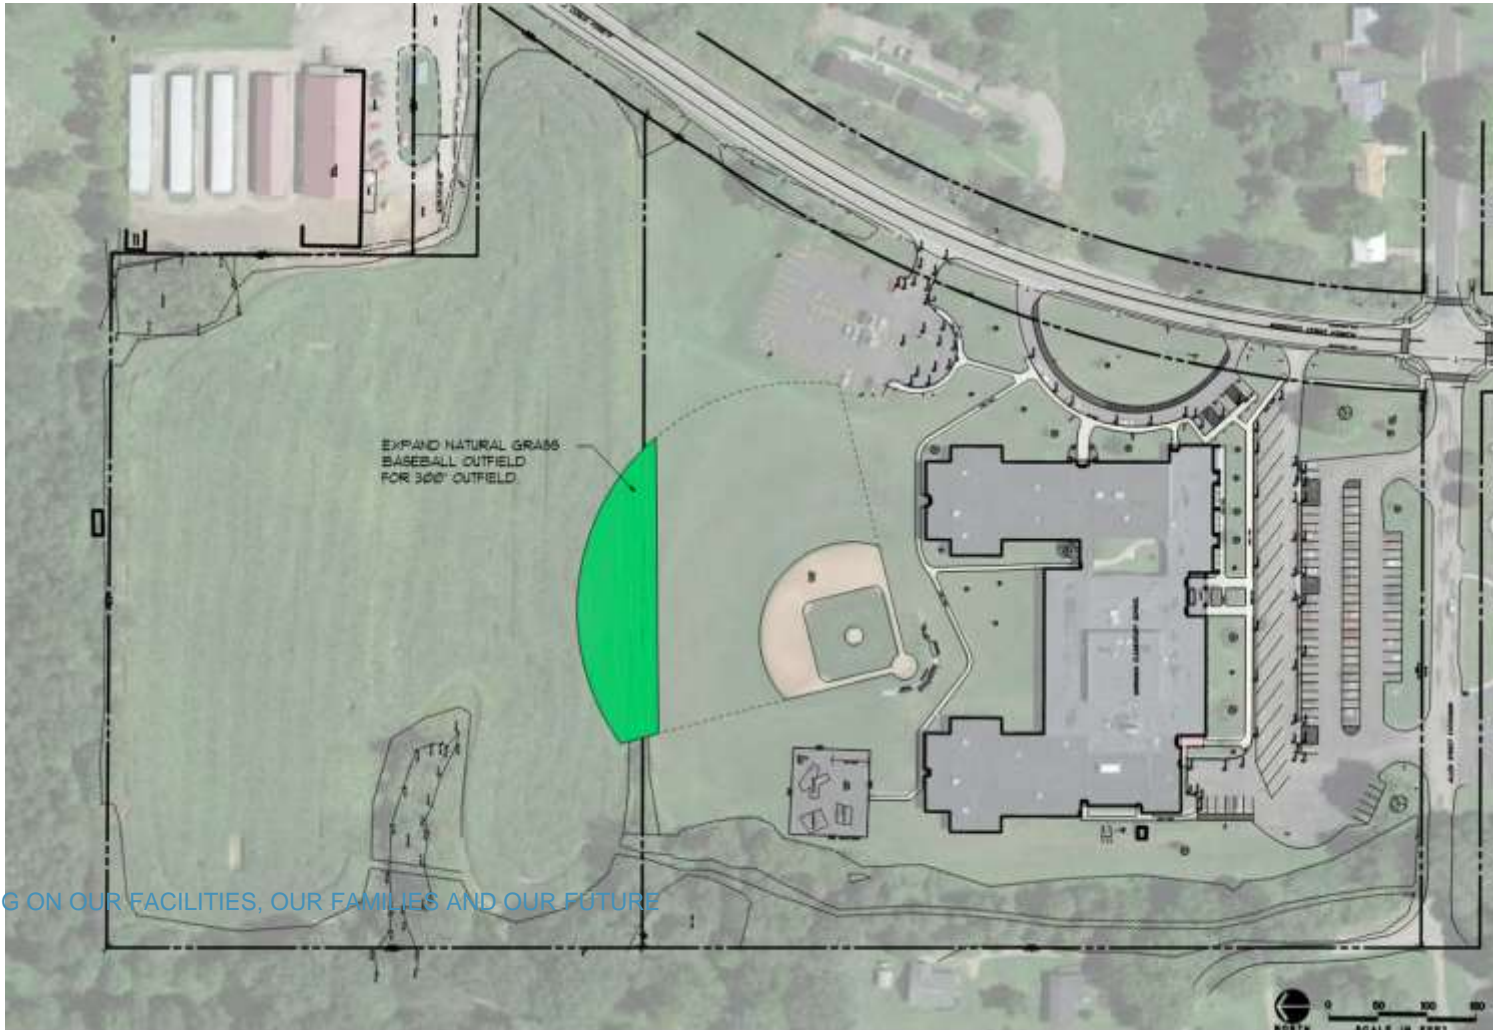
SITE IMPROVEMENT: ELEMENTARY CAMPUS

- EXPAND BASEBALL FIELD
- PROPERTY PURCHASE
 - **NOT IN FLOOD WAY**
